RE: Quick Mount PV Tile Replacement Mount
North Carolina State Compliance Letter

SEI Project No.: 19587.00

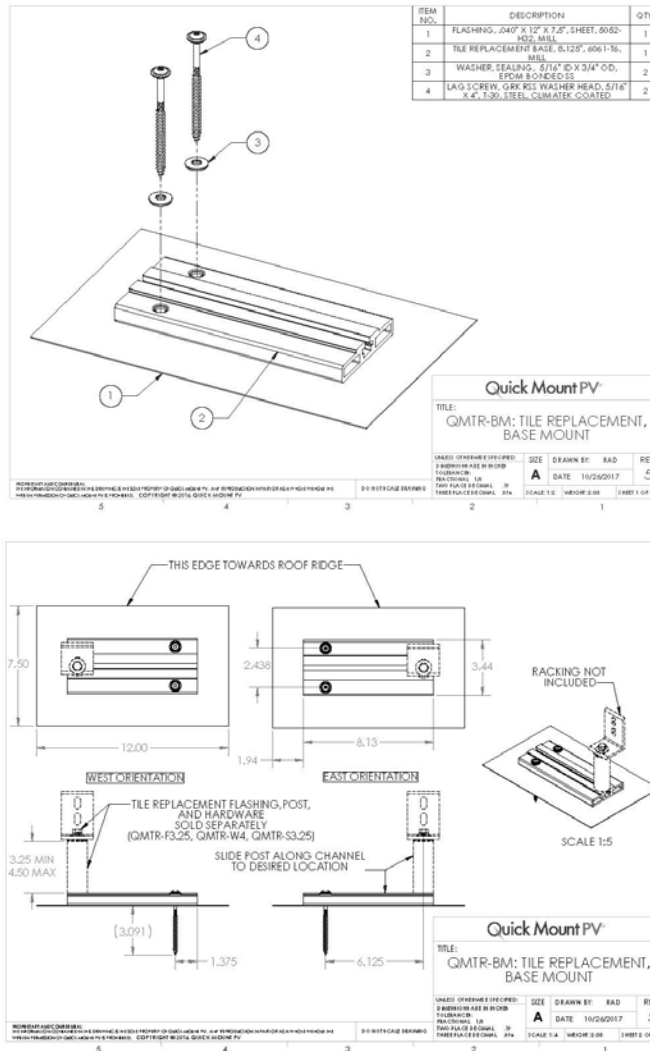
Figure 1: TRM Assembly

CTS is a licensed testing and engineering firm located at 2118 Rheem Drive, Pleasanton, CA 94588, where the testing of the TRM assembly was performed on February 26 thru March 5, and April 7 & 8, 2016 for the initial report. Testing for a 5.5" post option was performed between December 12, 2016 and January 6, 2017. The additional testing for the alternative screws was done on September 18 & 20, 2017 and was witnessed by Mar Structural Design, a licensed structural engineering firm. The TRM assembly is designed to support and fasten L-feet, rails, and PV modules manufactured by others to the structural roof framing through plywood or OSB sheathing and roofing material that support a tile-clad roof. Figure 1 below delineates the components of a TRM assembly.

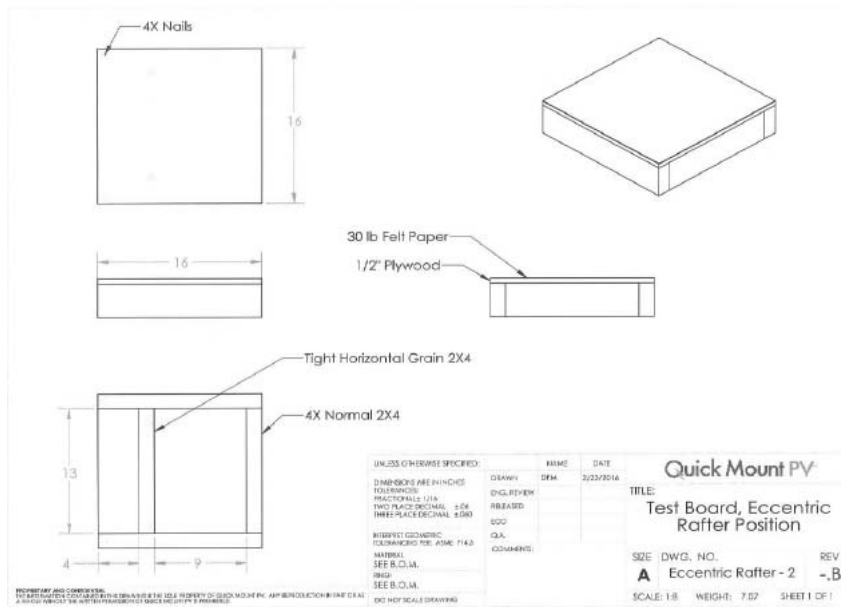
Figure 2a: Tension Test Board Configuration

- Testing of the TRM assembly consisted of test specimens that were made up of the following:
- a wood test bed representing a plywood-sheathed, wood framed roof that comprised of 15/32" APA-rated, PS1 plywood over 2x4 Douglas Fir rafters with a moisture content of 11 to 13% (See Figure 2a and 2b for test board configurations of the various specimens being tested),

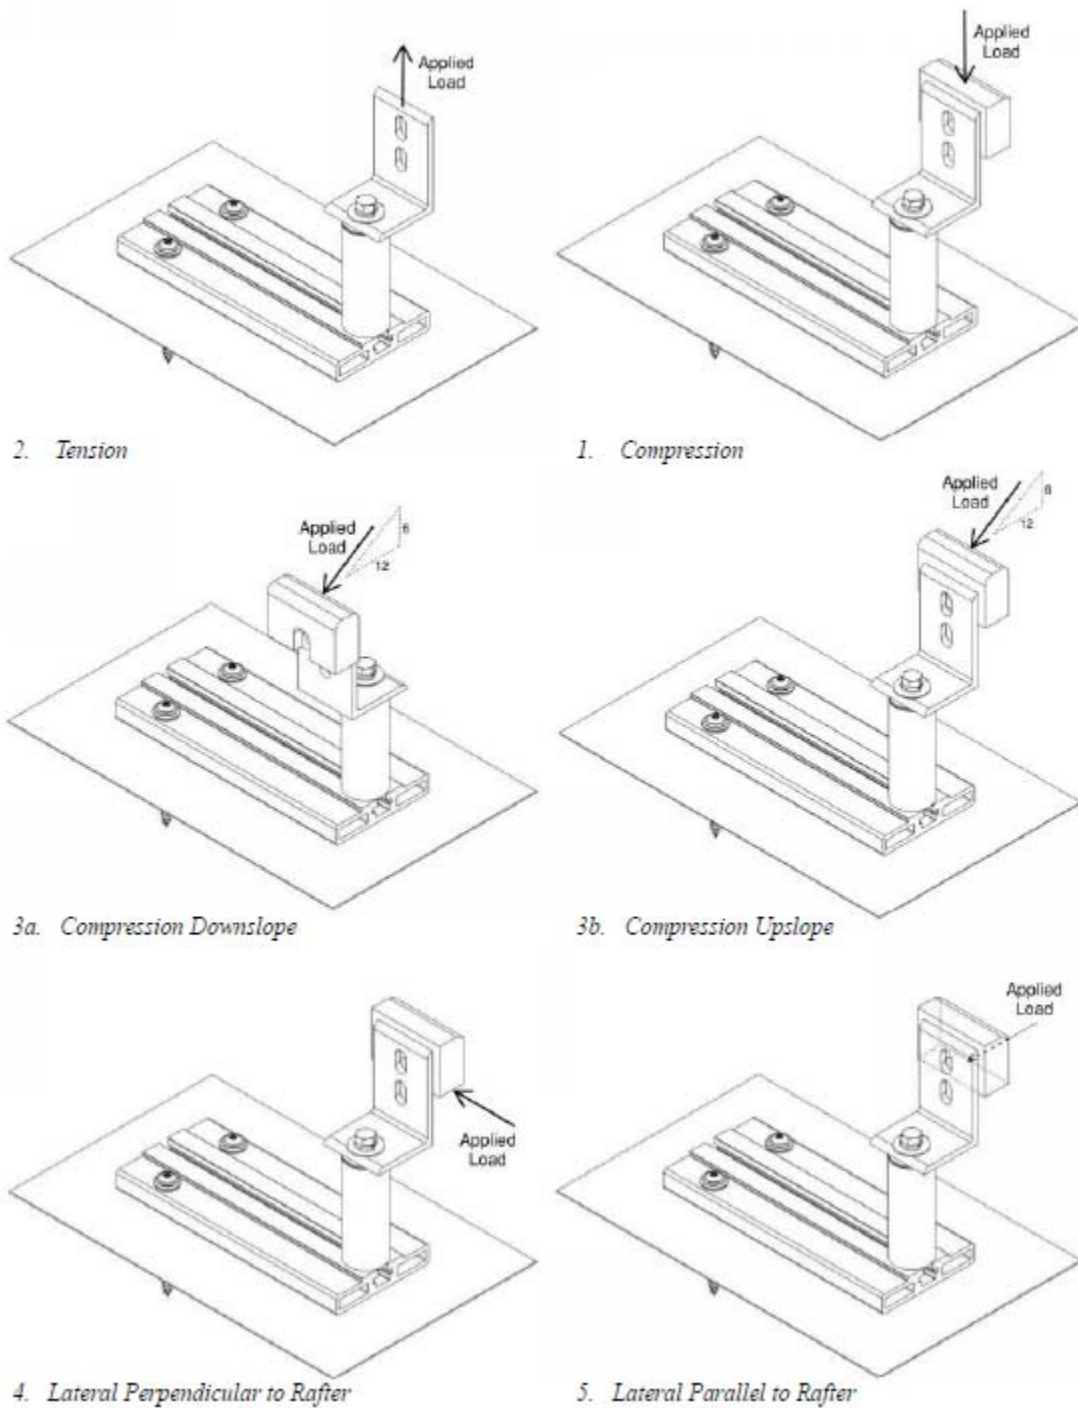
Figure 3: Loading Configurations of Each Test by CTS

- a conventional L-foot (UNIRAC product that is representative of a typical clip angle attachment commonly used in the solar industry) with a metal block attached to the L-foot to represent the rail that the PV modules are fastened to that cause an eccentric load onto the QPMV TRM. See Figure 3 for the Loading Configurations for the various tests applied to the specimens. It should be noted that the metal block is not used in every test.

The tests, with loadings applied as shown above, were created to simulate the reactions that would be applied to the L-foot bracket connection of the QMPV TRM due to the environmental loads projected on a PV solar roof array that is fastened to a roof by the QMPV TRM system. The tests were simulated for the environmental loads as follows:

- Tension test simulated wind uplift that was normal to the slope of the roof minus self-weight of the PV modules,
- Compression test simulated a low-slope roof condition and a steeper 6:12 slope condition. The low-slope roof compression test simulated a snow and array self-weight vertically down plus wind down normal to the slope of the roof. The 6:12 roof slope compression test with snow load parallel to roof slope being greatest simulated load applied with L-foot mounted on the upslope, as well as on the downslope side of the post to account for worst case eccentric loading.
- Lateral parallel to rafter simulated parallel to roof force component of downward snow and self-weight loads,
- Lateral perpendicular to rafter test simulated seismic loads on the cross-slope direction of the roof.

Tests were conducted such that the post was positioned on the base track at the furthest setting point from the structural screw connections in order to test the TRM base mount at its worst case for all loading conditions. While the post length is available in 3.25", 4", 4.5", & 5.5" options, the test specimens used the longest available post length in order to test the QMPV TRM under its most extreme layout for conservative results regarding its allowable capacities and serviceability deflections. Therefore, it should be noted that the CTS Test Report does not quantify the strengthening effect of using a smaller post length or positioning of the post on the base mount closer to the structural screw connection.
