May 26, 2020

RE: Quick Mount PV Tile Replacement Mount
Hawaii State Compliance Letter

SEI Project No.: 19587.00

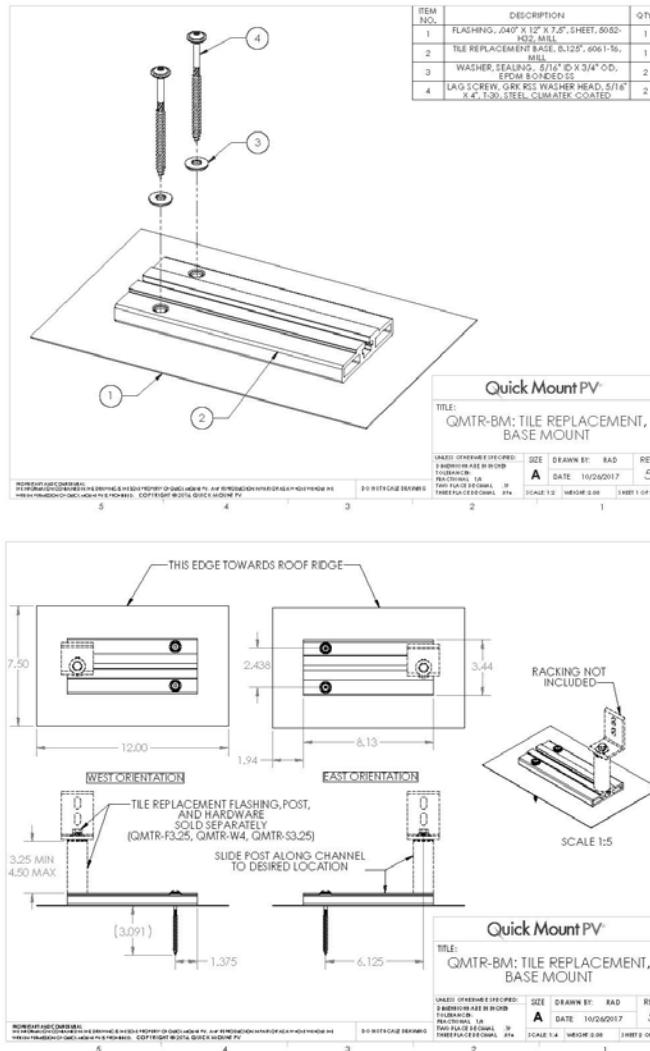
Figure 1: TRM Assembly

CTS is a licensed testing and engineering firm located at 2118 Rheem Drive, Pleasanton, CA 94588, where the testing of the TRM assembly was performed on February 26 thru March 5, and April 7 & 8, 2016 for the initial report. Testing for a 5.5" post option was performed between December 12, 2016 and January 6, 2017. The additional testing for the alternative screws was done on September 18 & 20, 2017 and was witnessed by Mar Structural Design, a licensed structural engineering firm. The TRM assembly is designed to support and fasten L-feet, rails, and PV modules manufactured by others to the structural roof framing through plywood or OSB sheathing and roofing material that support a tile-clad roof. Figure 1 below delineates the components of a TRM assembly.

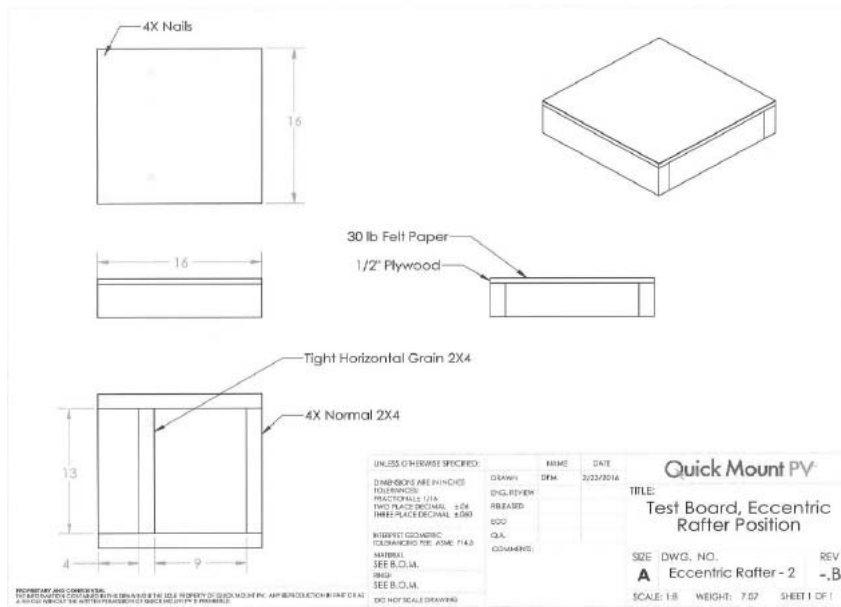
Figure 2a: Tension Test Board Configuration

- Testing of the TRM assembly consisted of test specimens that were made up of the following:
- a wood test bed representing a plywood-sheathed, wood framed roof that comprised of 15/32" APA-rated, PS1 plywood over 2x4 Douglas Fir rafters with a moisture content of 11 to 13% (See Figure 2a and 2b for test board configurations of the various specimens being tested),

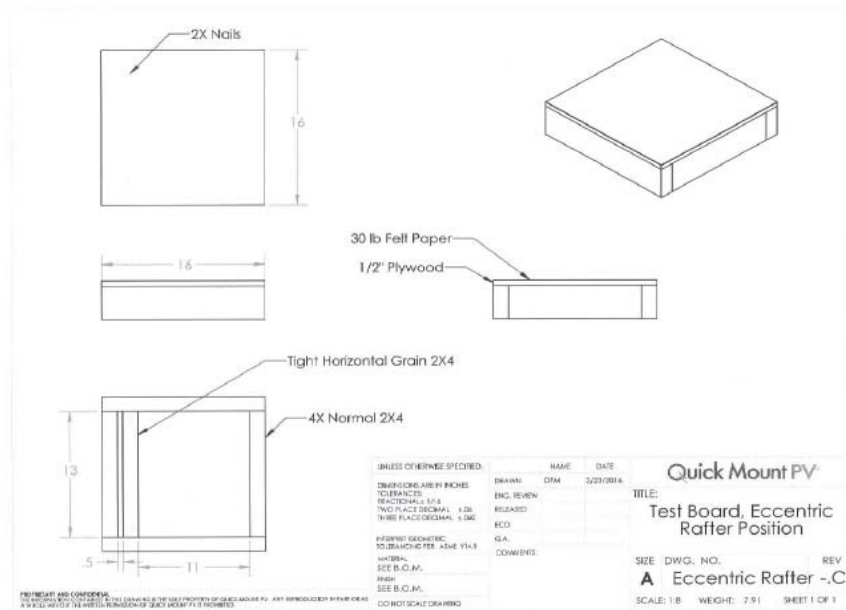
Figure 2b: Test Board Configuration For All Other Tests

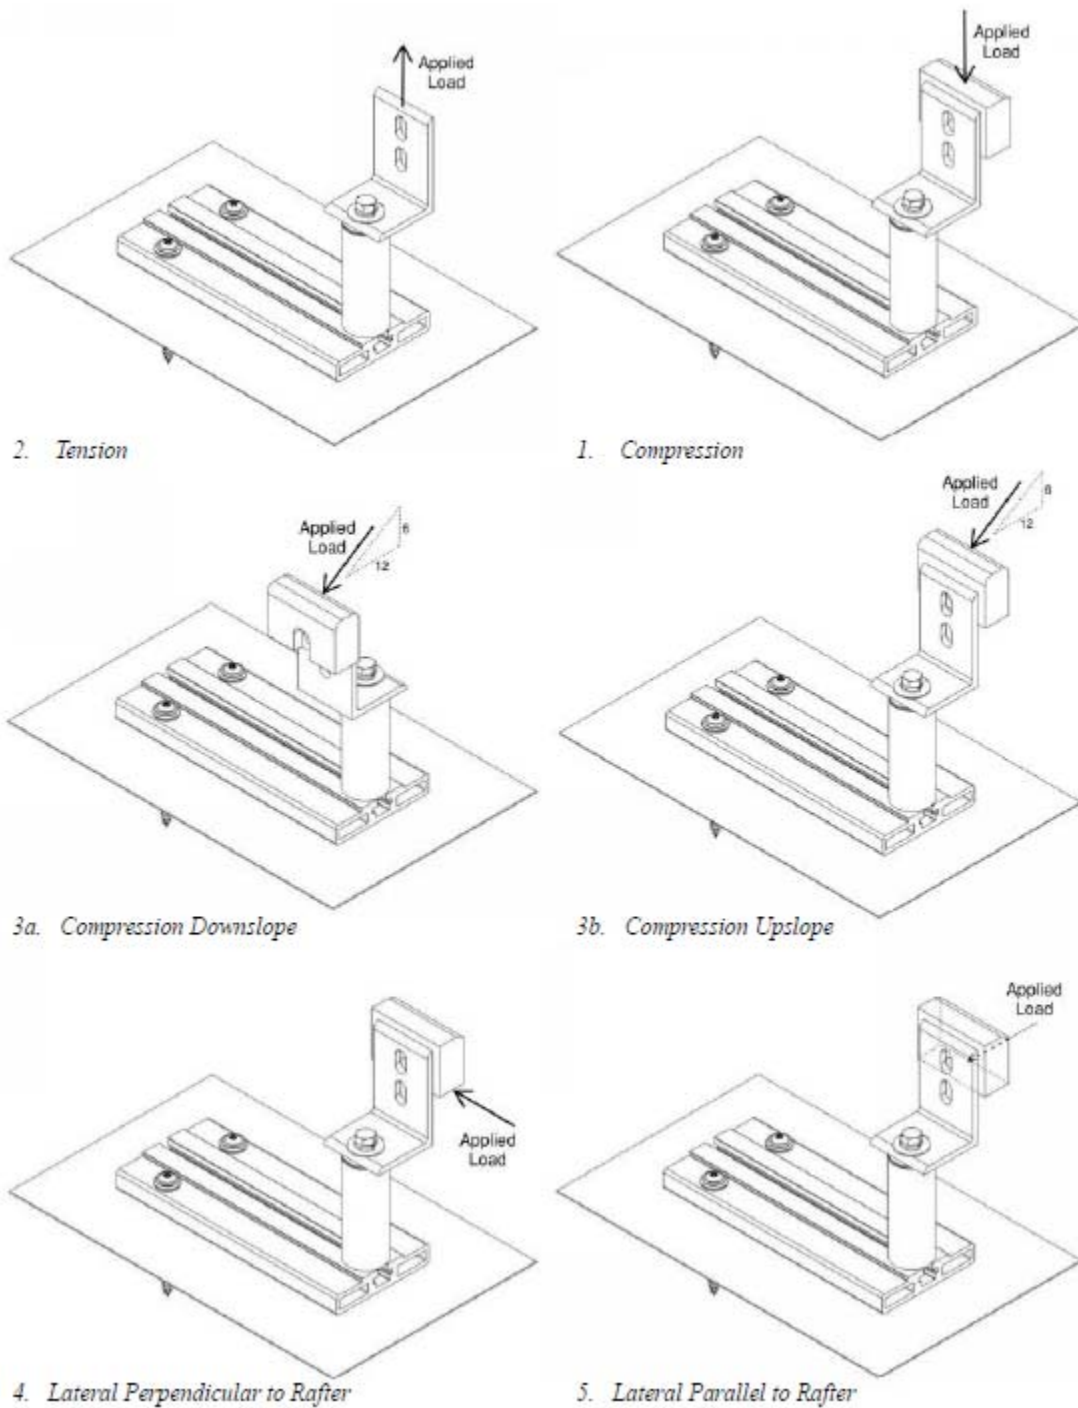
Figure 3: Loading Configurations of Each Test by CTS

- a conventional L-foot (UNIRAC product that is representative of a typical clip angle attachment commonly used in the solar industry) with a metal block attached to the L-foot to represent the rail that the PV modules are fastened to that cause an eccentric load onto the QPMV TRM. See Figure 3 for the Loading Configurations for the various tests applied to the specimens. It should be noted that the metal block is not used in every test.

The tests, with loadings applied as shown above, were created to simulate the reactions that would be applied to the L-foot bracket connection of the QMPV TRM due to the environmental loads projected on a PV solar roof array that is fastened to a roof by the QMPV TRM system. The tests were simulated for the environmental loads as follows:

- Tension test simulated wind uplift that was normal to the slope of the roof minus self-weight of the PV modules,
- Compression test simulated a low-slope roof condition and a steeper 6:12 slope condition. The low-slope roof compression test simulated a snow and array self-weight vertically down plus wind down normal to the slope of the roof. The 6:12 roof slope compression test with snow load parallel to roof slope being greatest simulated load applied with L-foot mounted on the upslope, as well as on the downslope side of the post to account for worst case eccentric loading.
- Lateral parallel to rafter simulated parallel to roof force component of downward snow and self-weight loads,
- Lateral perpendicular to rafter test simulated seismic loads on the cross-slope direction of the roof.

Tests were conducted such that the post was positioned on the base track at the furthest setting point from the structural screw connections in order to test the TRM base mount at its worst case for all loading conditions. While the post length is available in 3.25", 4", 4.5", & 5.5" options, the test specimens used the longest available post length in order to test the QMPV TRM under its most extreme layout for conservative results regarding its allowable capacities and serviceability deflections. Therefore, it should be noted that the CTS Test Report does not quantify the strengthening effect of using a smaller post length or positioning of the post on the base mount closer to the structural screw connection.
