RE: Quick Mount PV Tile Replacement Mount  
New Jersey State Compliance Letter

SEI Project No.: 16411.00

Structural Enginuity Inc. (SEI) submits this letter regarding our review of the test data for the Quick Mount PV (QMPV) Tile Replacement Mount (TRM) photovoltaic (PV) array mounting system. The test data is from the Constructive Testing Services (CTS) Test Report number 11304, titled, "Quick Mount PV Load Testing – Tile Replacement Mount [QMPV# 1-28-2016-REV C]", dated April 29, 2016 and is available upon request from QMPV. Further testing was performed at the QMPV facility in Walnut Creek, California using alternative structural screws.

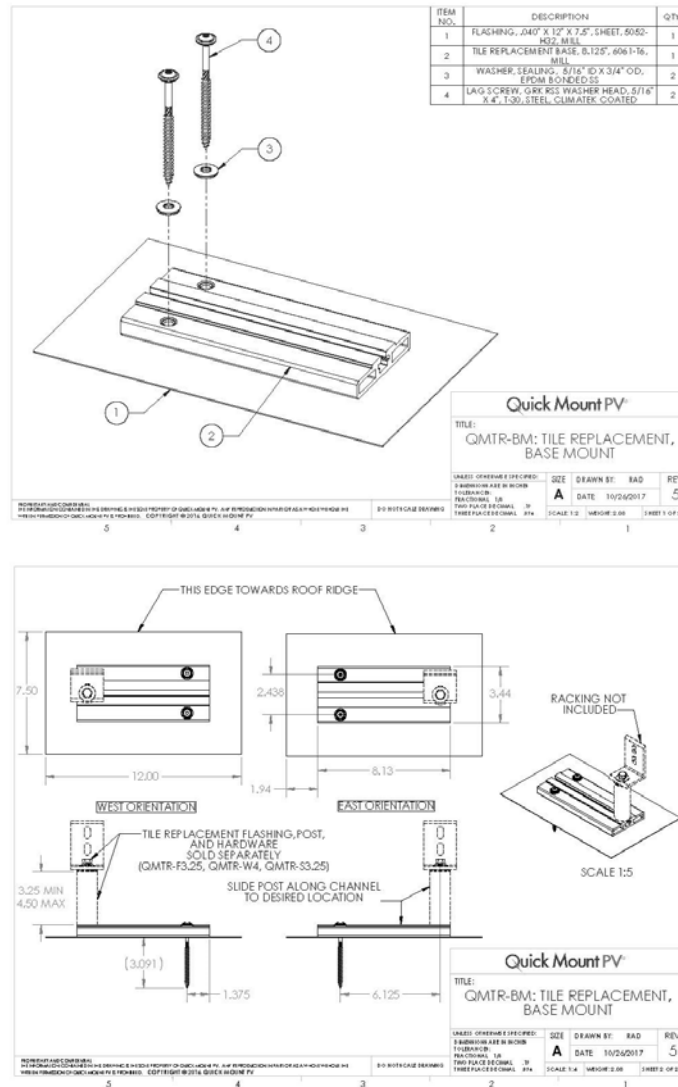
**Figure 1: TRM Assembly**

CTS is a licensed testing and engineering firm located at 2118 Rheem Drive, Pleasanton, CA 94588, where the testing of the TRM assembly was performed on February 26 thru March 5, and April 7 & 8, 2016. The additional testing for the alternative screws was done on September 18 & 20, 2017 and was witnessed by Mar Structural Design, a licensed structural engineering firm. The TRM assembly is designed to support and fasten L-feet, rails, and PV modules manufactured by others to the structural roof framing through plywood or OSB sheathing and roofing material that support a tile-clad roof. Figure 1 below delineates the components of a TRM assembly.

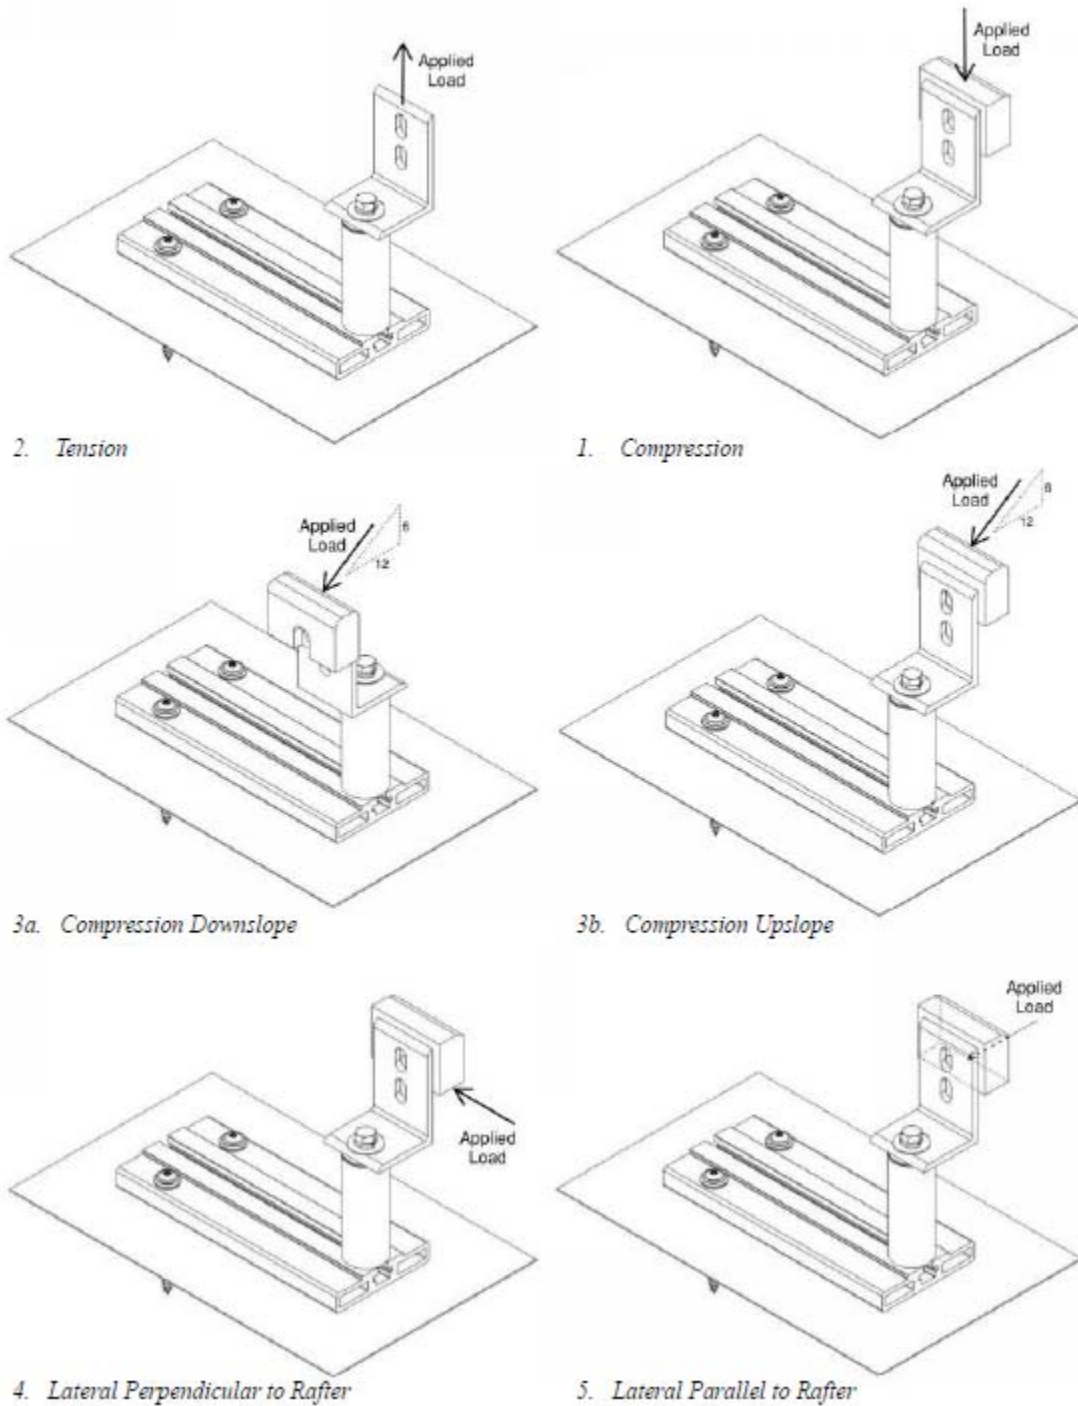
**Figure 3: Loading Configurations of Each Test by CTS**

- a QMPV 4-1/2" long post,
  - a conventional L-foot (UNIRAC product that is representative of a typical clip angle attachment commonly used in the solar industry) with a metal block attached to the L-foot to represent the rail that the PV modules are fastened to that cause an eccentric load onto the QPMV TRM. See Figure 3 for the Loading Configurations for the various tests applied to the specimens. It should be noted that the metal block is not used in every test.

The tests, with loadings applied as shown above, were created to simulate the reactions that would be applied to the L-foot bracket connection of the QMPV TRM due to the environmental loads projected on a PV solar roof array that is fastened to a roof by the QMPV TRM system. The tests were simulated for the environmental loads as follows:

- Tension test simulated wind uplift that was normal to the slope of the roof minus self-weight of the PV modules,
- Compression test simulated a low-slope roof condition and a steeper 6:12 slope condition. The low-slope roof compression test simulated a snow and array self-weight vertically down plus wind down normal to the slope of the roof. The 6:12 roof slope compression test with snow load parallel to roof slope being greatest simulated load applied with L-foot mounted on the upslope, as well as on the downslope side of the post to account for worst case eccentric loading.
- Lateral parallel to rafter simulated parallel to roof force component of downward snow and self-weight loads,
- Lateral perpendicular to rafter test simulated seismic loads on the cross-slope direction of the roof.

Tests were conducted such that the post was positioned on the base track at the furthest setting point from the structural screw connections in order to test the TRM base mount at its worst case for all loading conditions. While the post length is available in 3.25", 4", and 4.5" options, the test specimens used the longest available post length in order to test the QMPV TRM under its most extreme layout for conservative results regarding its allowable capacities and serviceability deflections. Therefore, it should be noted that the CTS Test Report does not quantify the strengthening effect of using a smaller post length or positioning of the post on the base mount closer to the structural screw connection.
